Water Accessibility and Potability Project: Las Mercedes & El Naranjito El Salvador 2008

Ann Campana Judge Foundation Project Report

Engineers Without Borders – Oregon State University

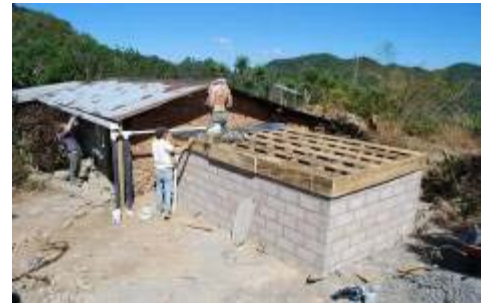
View of the rainwater catchment tank as the roof is being constructed.

In December 2008, a team of six student members of EWB-OSU and one Professional Mentor traveled to El Naranjito to build rainwater catchment systems for families in the isolated community of Cerro Caballo (a sub-community of El Naranjito). Three households are located in the ridgetop community of Cerro Caballo, approximately one mile from El Naranjito proper. Of all the homes surveyed by EWB-OSU, families in Cerro Caballo walk the farthest for their water. As no sources of gravity-fed water were available to serve Cerro Caballo, EWB-OSU chose to construct rainwater catchment systems, consisting of rooftop collection, gutters to transport the water, temporary rain barrels to serve water needs during the rainy season, and long-term storage tanks to store water for the dry season. EWB-OSU also constructed concrete laundry stations near each storage tank. To preserve quality of the stored water, each tank was equipped with a lid, and each system also included a first-flush mechanism that prevented the first 1 mm of runoff from entering drinking water storage. This 1 mm was stored separately where it could be used for non-consumptive uses.

The sheer size of the rainwater catchments tanks constructed on the December 2008 trip was a difficulty in itself, and the time-sensitive pouring of the foundation was a particular concern. The team rented a gasoline-powered cement mixer to solve this problem, rather than hand-mixing the cement in the traditional fashion. They also hired an additional mason to help finish the tank walls within the scheduled time.

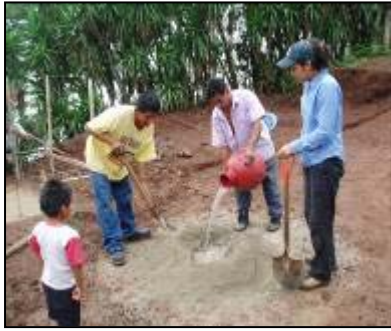
An EWB-OSU member works with beneficiaries to mix cement by the "volcano method."

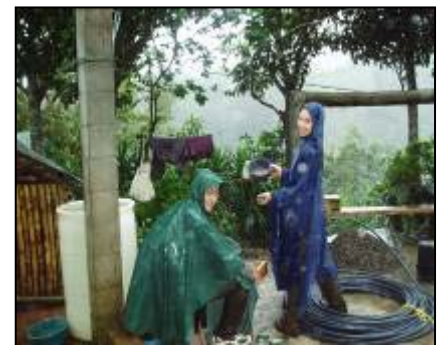
Two EWB-OSU team members sift sand during a downpour.

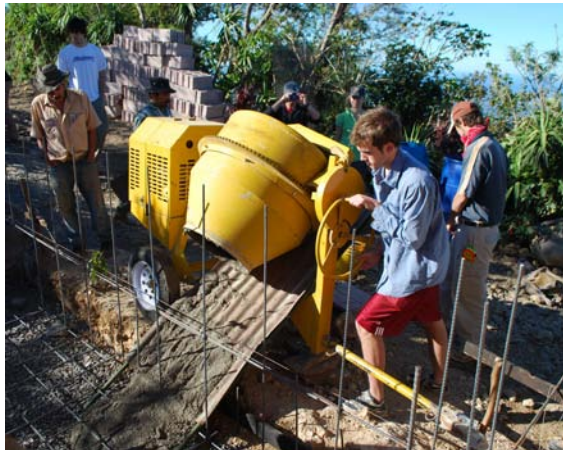
Pouring the foundation at the sub-community of Cerro Cabollo on the December 2008 Trip.
